Structural Analysis & Bridge Load Rating Report

Kern Bridge

(formerly MnDOT Bridge No. L5669)

Report Date August 31, 2017

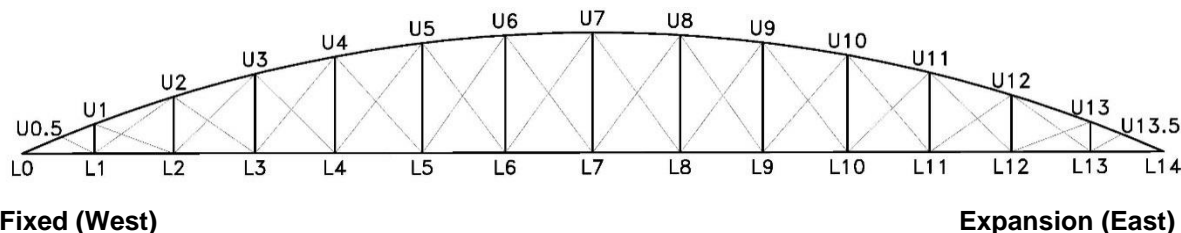
Sketch 1: South Truss/Arch Elevation Looking North

The bottom chord tension members are in fair condition. Impact damage to the bottom chord members was noted in four locations on the south (upstream) truss/arch. The bottom chord splice plates are distorted from minor pack rust. The built-up top chord configuration is commonly referred to as a Phoenix Column (see Photo 8). The Phoenix Columns appeared in good condition with no significant defects noted. The built-up vertical members are in fair condition with minor pitting noted, especially near the connection to the lower chord. Some loss of section was noted at these locations, amounting to 5 percent or less loss of original section. The round stock diagonal members are in good to fair condition.

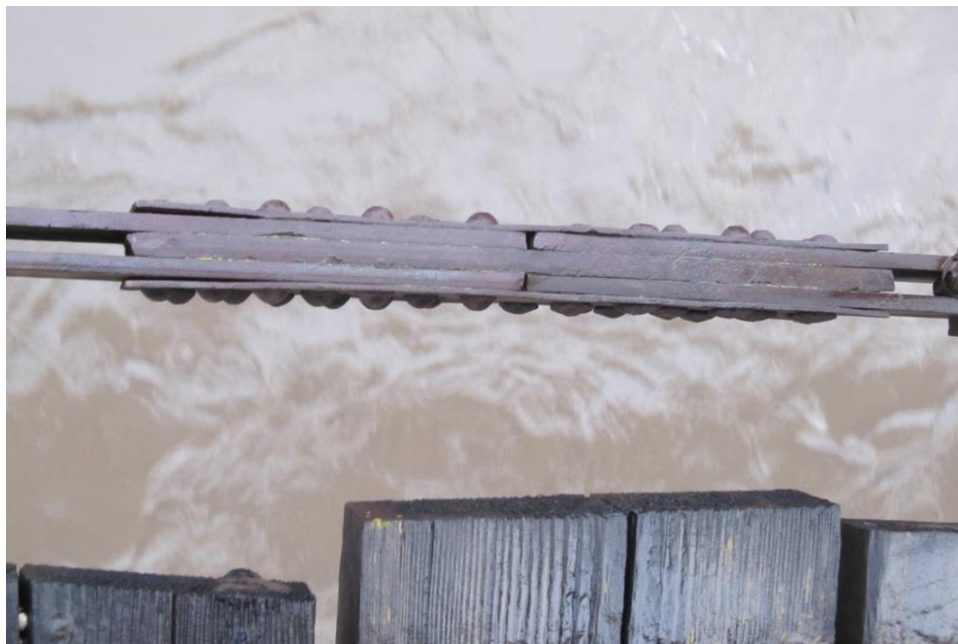
Photo 7: Bottom chord showing distortion of splice plates

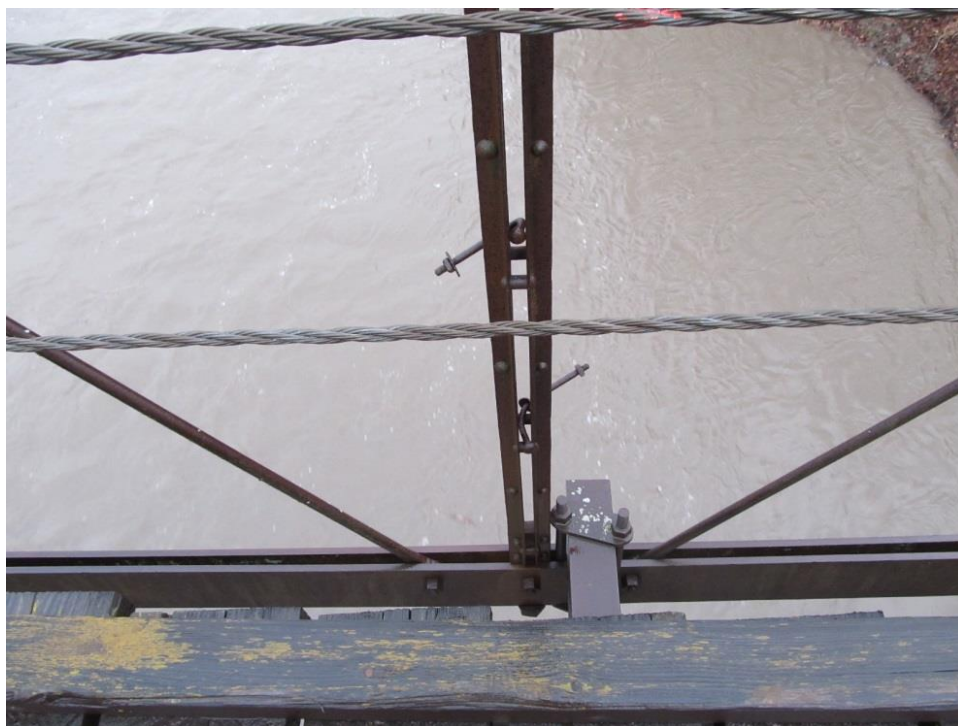
A previous bridge railing appears to have been removed, as evidenced by hardware and brackets that remain on the structure. The two lines of wire rope that have been installed on each truss/arch to function as railings are in good condition, though the railing geometry and configuration does not meet current standards for either pedestrian/bikeway or vehicular traffic.

Photo 10: Typical built-up vertical member (note previous railing hardware remaining)

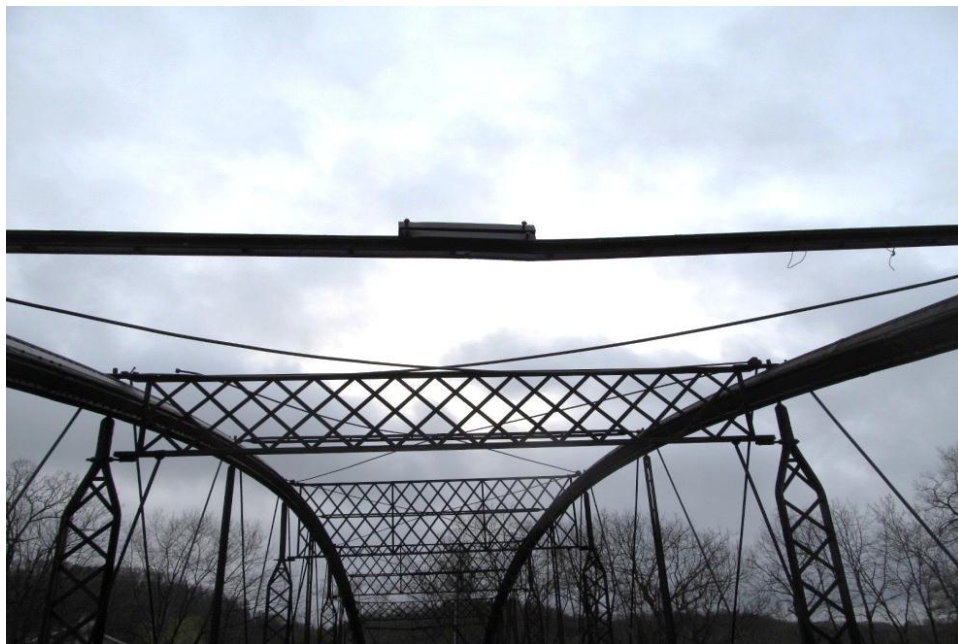
Two of the portals on the west end of the truss/arch are damaged from impacts. Bolts are missing from the connections between the bottom chord and bracing members at several locations along the length of the bridge. The upper sway brace connection in the southeast corner of the bridge is broken. The X-bracing in the plane of the floor system is currently ineffective with the members mostly disconnected and hanging off the bridge.

Photo 11: End portals and sway braces

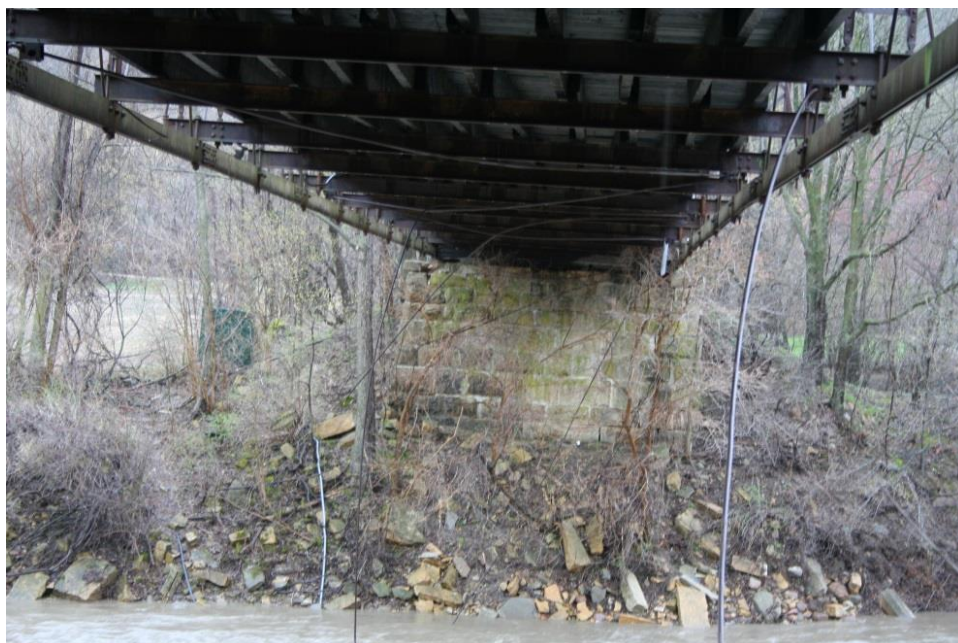
The truss/arch floorbeams appeared to be in good to fair condition, though close examination was only possible at either end of the truss/arch (L1 and L13). The timber stringers that were accessible also appeared to be in good to fair condition.

Photo 12: Floorbeams and timber stringers (note hanging X-bracing)

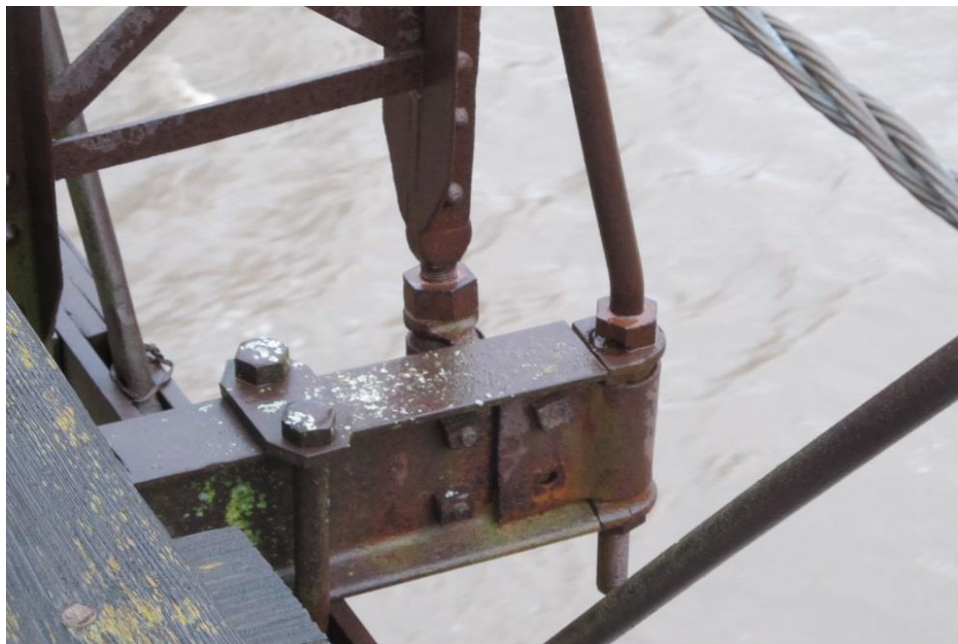
Photo 13: Missing bolt at secondary member connection (1 of 2)

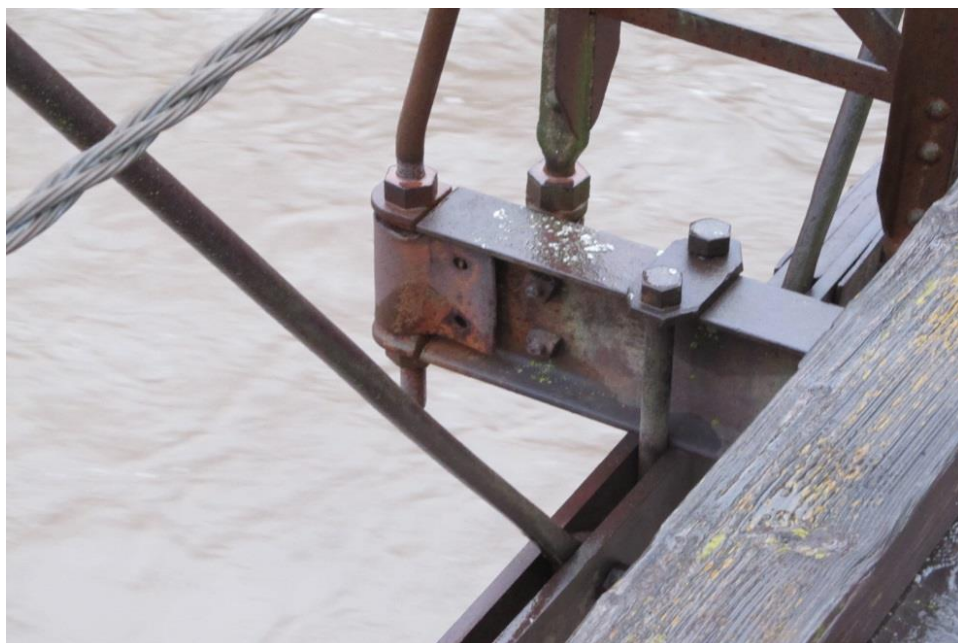
Photo 14: Missing bolts at secondary member connection (2 of 2)

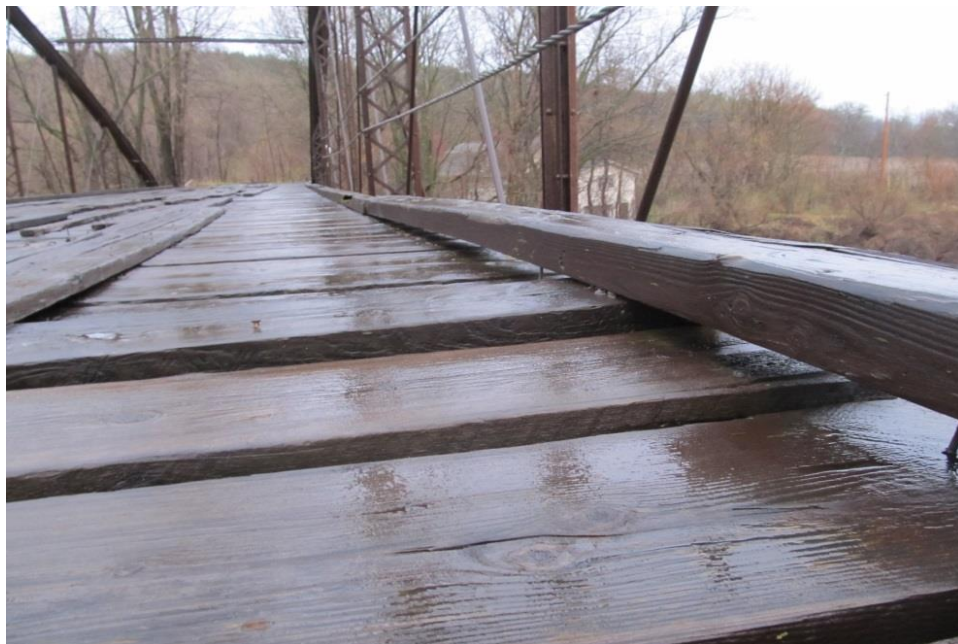
The transverse timber deck planks are in fair condition, with approximately 30 individual planks requiring replacement due to damage and/or decay. The timber curbs are in fair condition with an estimated 30 linear feet of damaged or decayed curb requiring replacement. The longitudinal timber running planks are in poor condition and require 100 percent replacement. The existing broken and decayed running planks along with exposed nails and hardware present a serious tripping hazard that, coupled with the non-conforming railings, present a serious safety risk.

Photo 15: Timber deck (note uneven surface, potential tripping hazard)

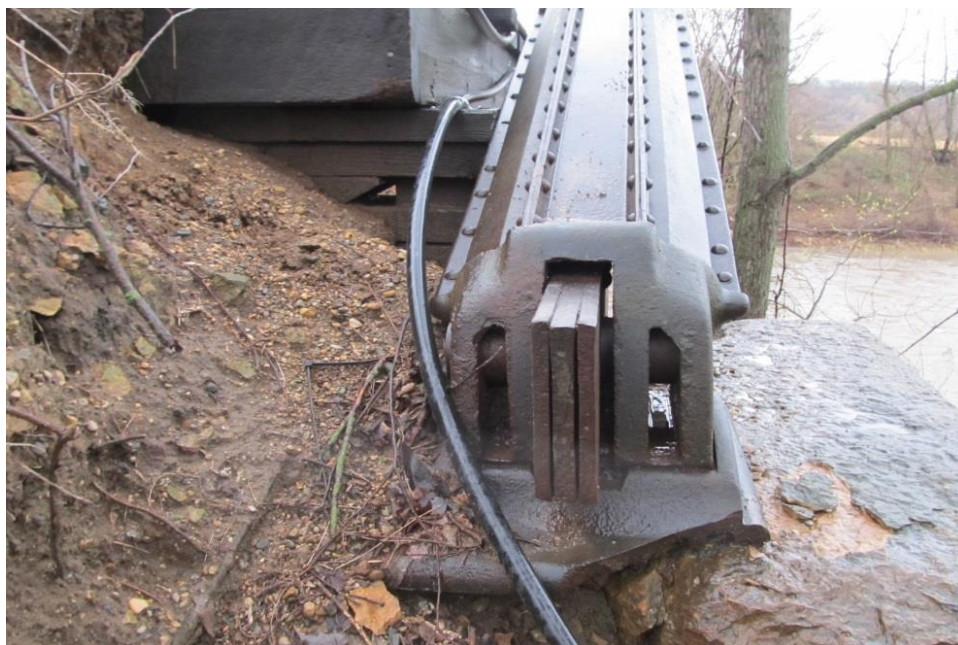
Truss/arch bearings are non-functioning and mostly buried in earth. Movement of the truss/arch independent of the bearings has caused cracks and dislocation of the stone masonry at the east abutment.

Photo 16: Bearing at east abutment

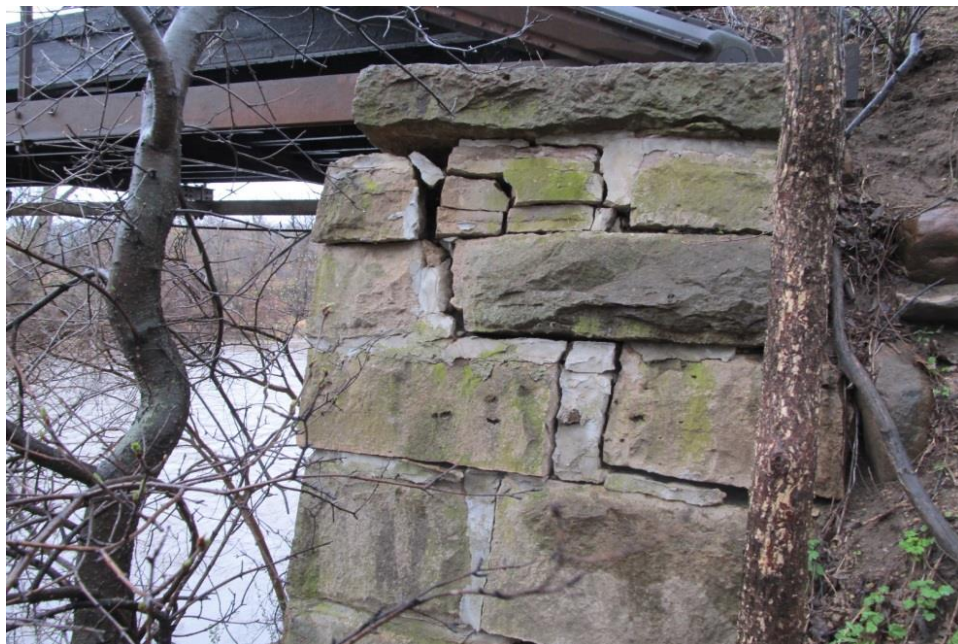
The stone masonry abutments are in poor condition, especially the east abutment. The masonry at the east abutment is cracked and some of the stones are dislodged from their original position, particularly near the truss/arch supports where non-functioning expansion bearings have transmitted unintended lateral forces to the masonry. In addition, the foundation of the east abutment at the south end has settled, causing vertical translation of the bottom chord at this location. This condition may also be responsible for the broken sway brace connection in the southeast corner discussed in the “Wrought Iron Truss/Arch-Portal and Secondary Members” section above. The southeast slope has washed out, resulting in exposure of the stone masonry abutment back face. The west abutment has been underpinned in the past to correct undermining.

Photo 17: East abutment masonry dislocation, southeast corner

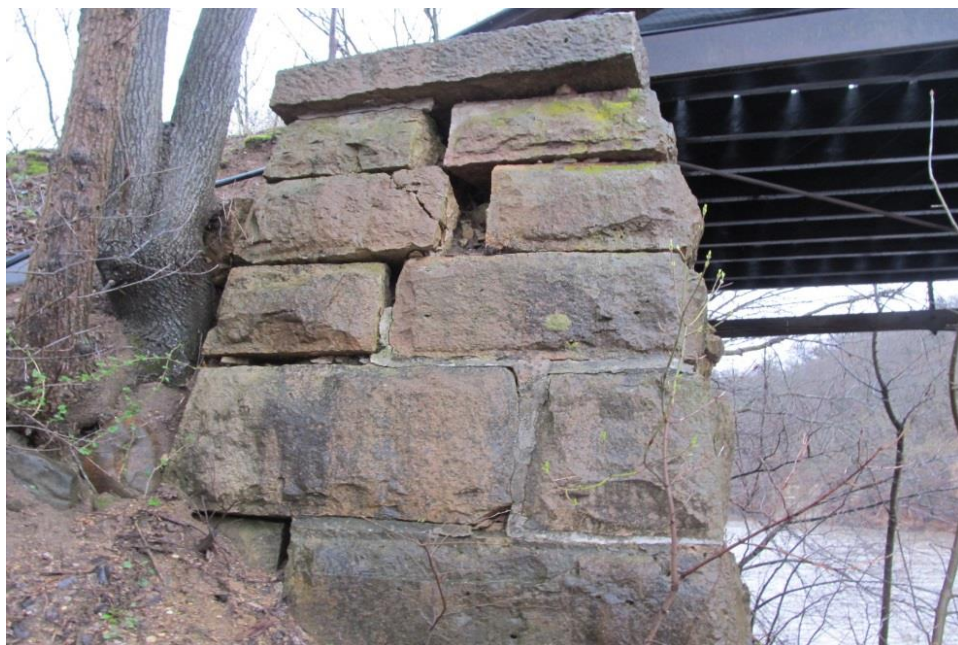
Photo 18: East abutment masonry dislocation, northeast corner

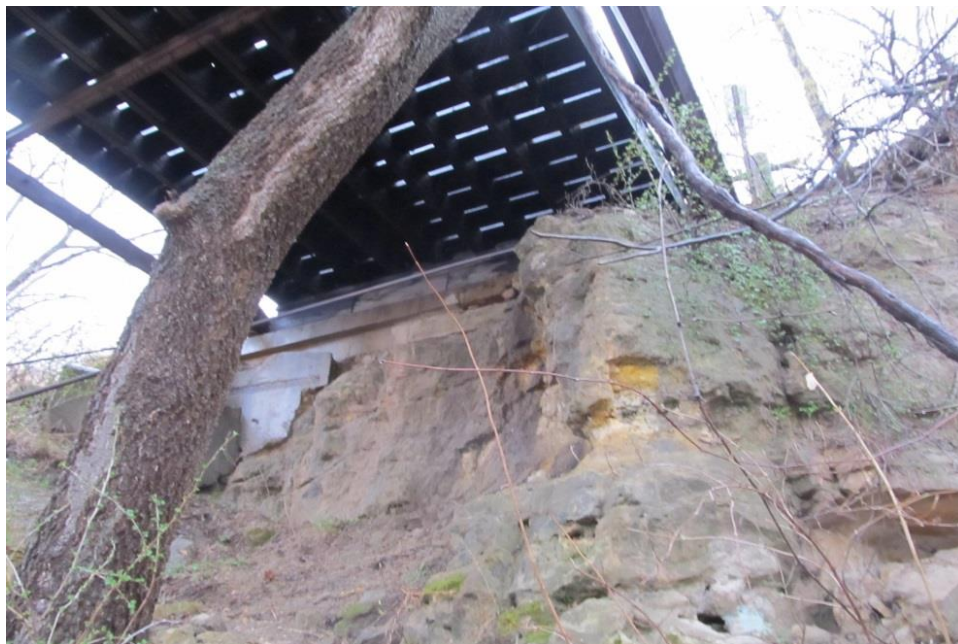
Photo 19: West abutment

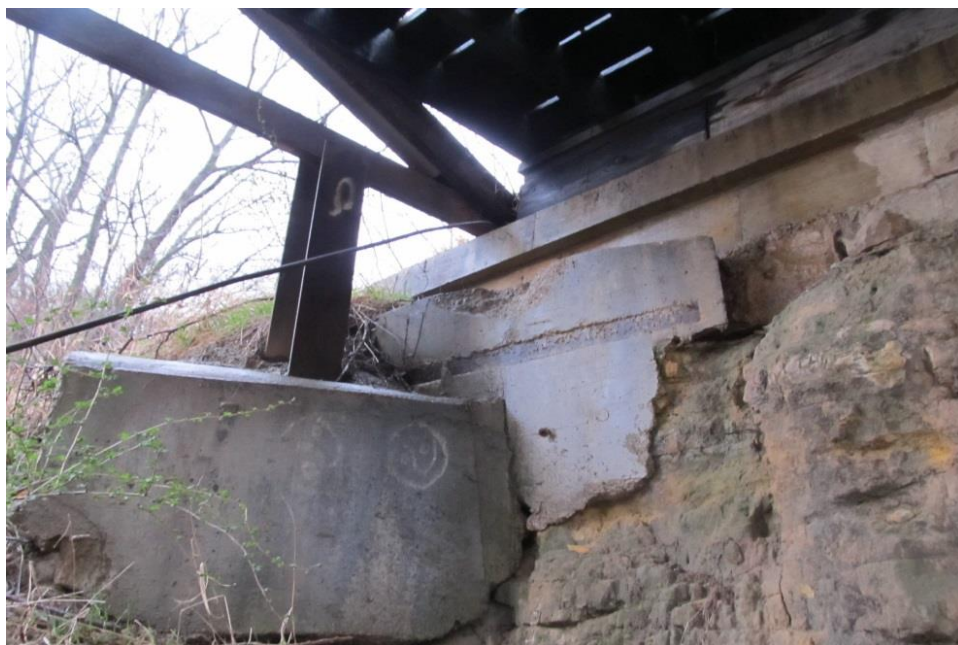
An independent support of the bottom chord consisting of a steel H-pile section supported on a concrete pad poured on the bedrock is present in the southwest corner. While it is unclear whether or not this rough shoring apparatus is actually supporting the truss/arch, it should be removed prior to subjecting the truss/arch to any significant live or dead loading. The location of the temporary support is far enough from the bearing location that it will introduce loading directions and magnitudes that the truss/arch is not designed to accommodate. Crippling of the bottom chord and collapse of the bridge is a likely scenario if the bridge is subjected to vehicular live loads with this support in place.

Photo 20: Truss/arch support in southwest corner

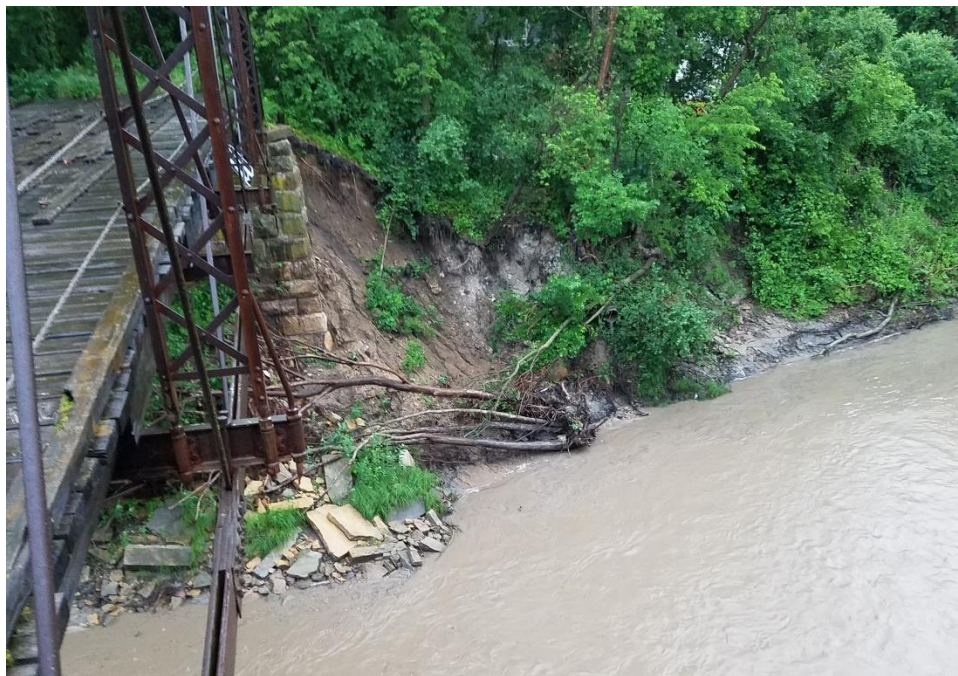
Photo 23: Southeast slope washout

The southeast slope wash out, poses concern to the stability of the bridge substructure and possible failure or collapse of the bowstring truss/arch superstructure. The approximate timing of the wash out is believed to have occurred in September of 2016; based on LHB site visits within recent years and historical water level and flow data obtained from the United States Geological Survey (USGS) National Water Information System, per measuring instrument located on the Kern Bridge. Though, the bridge and abutment appeared to be stable at the time of LHB's most recent site visit, June 12, 2017, it is highly unpredictable to know when the next rain or flood event may occur, possibly resulting in further erosion of the bridge slopes. Thus, the susceptibility to further erosion at the east abutment during high flow events and unknown depth and footing bearing condition for the abutment makes the continued stability of the bridge from collapse unpredictable. One option to help stabilize the slopes could be to place riprap along the southeast slope to help protect from further erosion. For purposes of this study, no cost has been associated with placing riprap at the current bridge location.

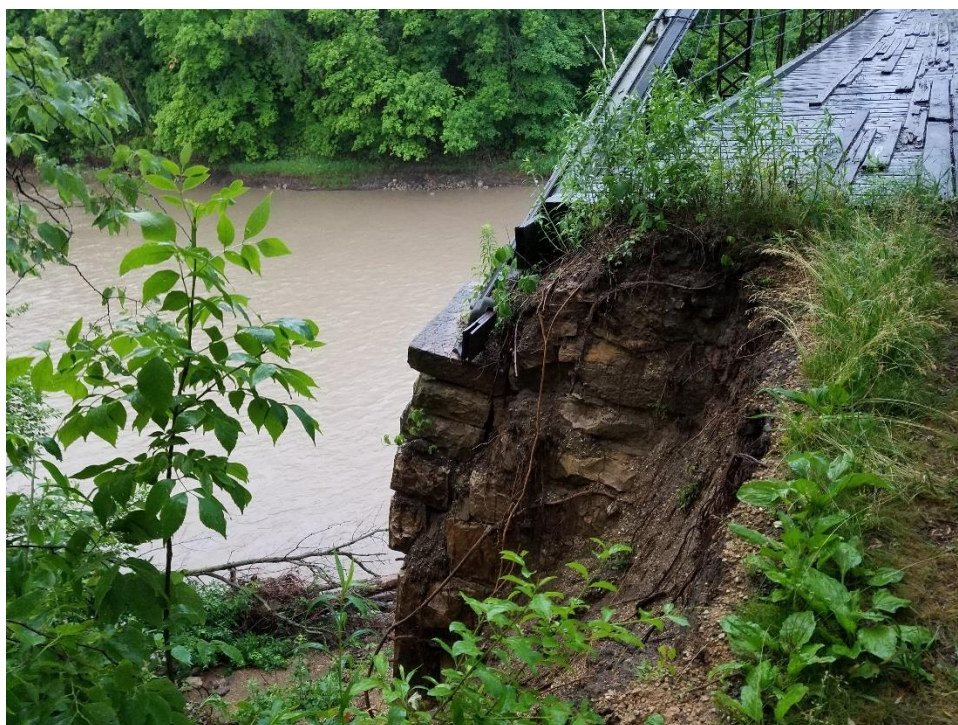
Photo 24: Southeast slope washout, exposed stone masonry abutment
